# POST HURRICANES EVALUATION OF THE SUBMERGED REEF BALL BREAKWATER AT THE MAYAN PALACE RESORT, QUINTANA ROO, MEXICO

Performed by: Dr. Lee E. Harris, Ph.D., P.E.  
Consulting Coastal-Ocean-Civil Engineer and Physical Oceanographer  
Associate Professor of Ocean Engineering & Oceanography  
Division of Marine & Environmental Systems  
Florida Institute of Technology  
Melbourne, FL 32901 USA

Performed for: Lic. Mario Chacon Ramos  
Marenter, S.A. de C.V.  
Cancun, Q. Roo, Mexico

October 2005

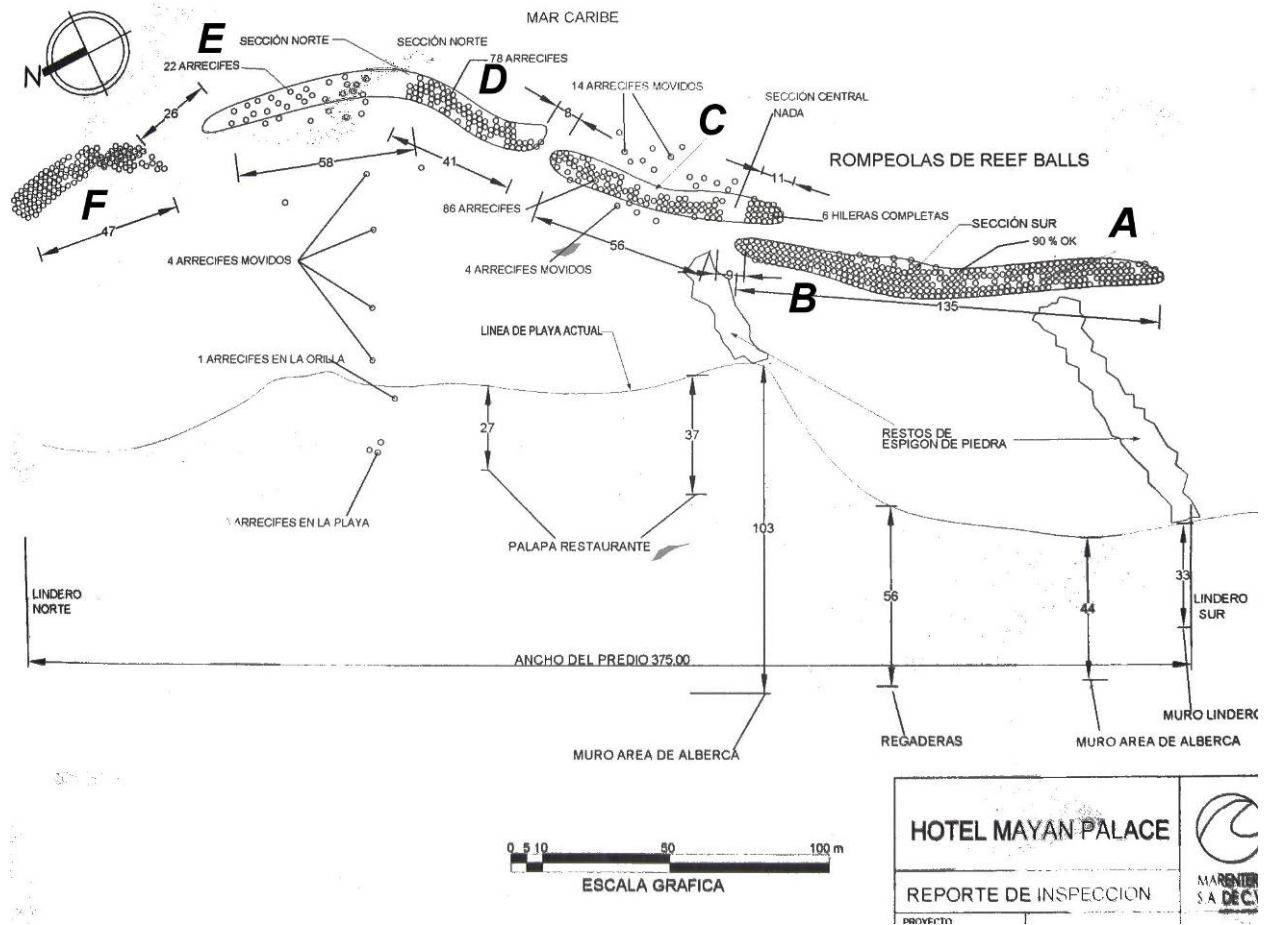
Figure 5. Post Hurricane Ivan Survey Performed by Marenter

Figure 5 shows the post Hurricane Ivan survey performed by Marenter. The different regions of the breakwater are labeled **A** through **F** from south to north as shown in Figure 5 and subsequent Figures, to provide a numbering system to assist with discussions of the performance of different sections of the breakwater system.

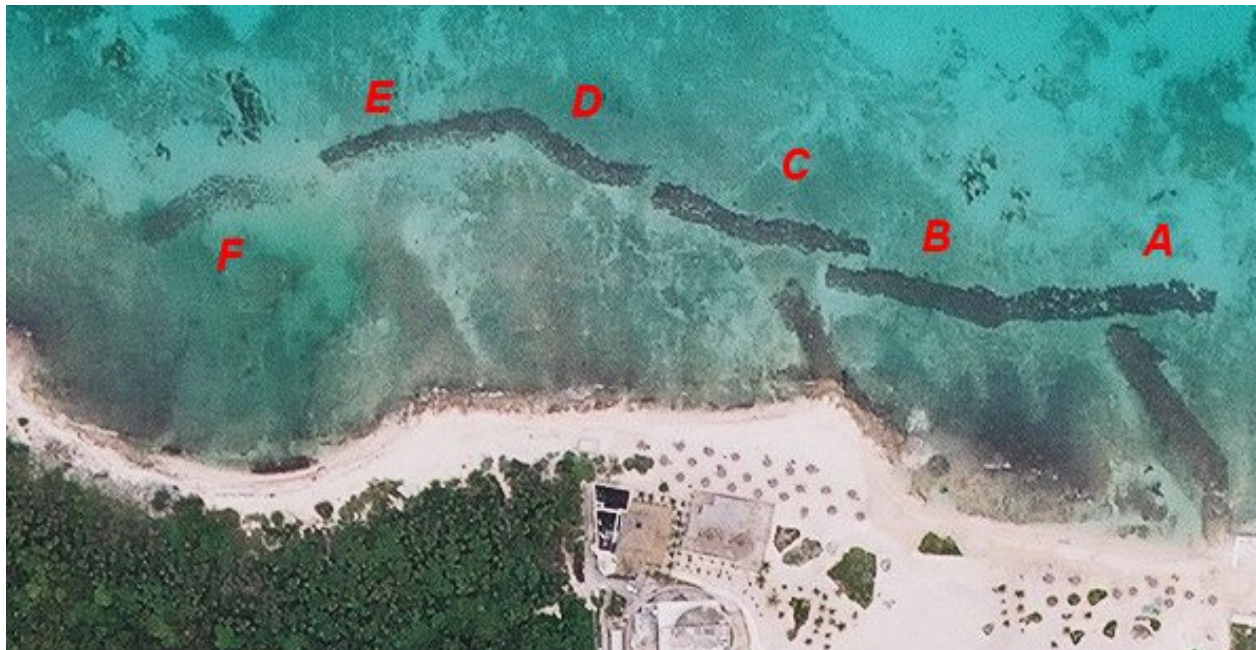
Figure 6. As-built and Pre-Hurricane Ivan Aerial Photograph

Figure 6 shows an aerial photograph taken after construction of the breakwater, and provides a good comparison of the as-built condition compared to the post-Hurricane Ivan condition shown in the survey in Figure 5 (directly above Figure 6 for comparison).

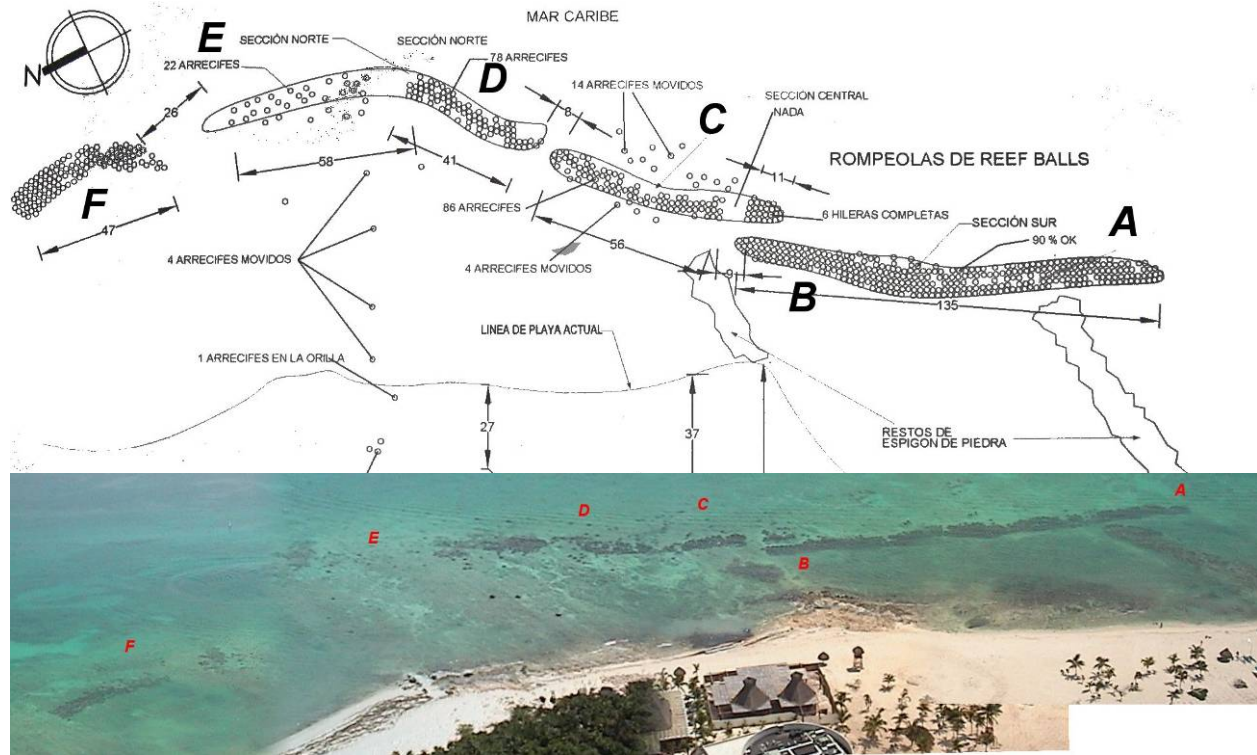
Figure 7. Post-Hurricane Ivan Aerial Photograph

Figure 7 shows an aerial photograph taken after Hurricane Ivan, and provides good comparisons to the as-built photographs and to the post-Hurricane Ivan condition shown in the survey (reproduced as part of Figure 7 for comparison). Figure 8 shows a close-up aerial photograph of all of the breakwater regions after Hurricane Ivan, except for Region F which is further north of the area photographed.

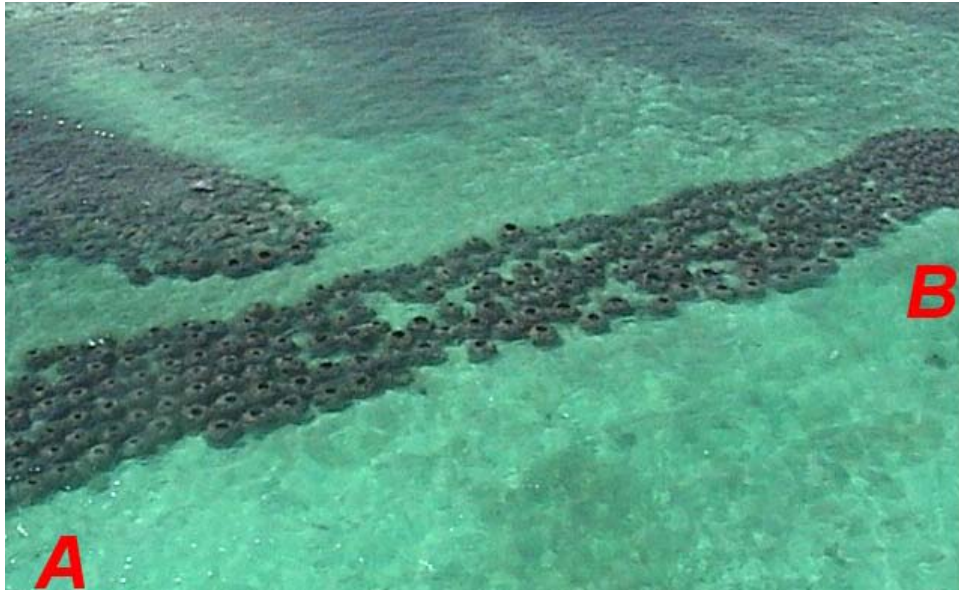
**Figure 9. Aerial Photograph – Region A-B**

Figures 7 and 8 show that the Reef Ball breakwater regions A and B remained unchanged after impacted by Hurricane Ivan. A close-up aerial photograph of that area is shown in Figure 9. This was the first breakwater portion to be constructed, and inspection of the units indicates that the concrete quality, fabrication of anchoring sleeves, and anchoring was satisfactory. Hence this part of the breakwater performed well under the wave attack due to the major hurricanes. Figure 10 shows the overlap of the Reef Ball breakwater at regions B and C. This overlap is greater than necessary, and was not the most effective use of the Reef Ball units.

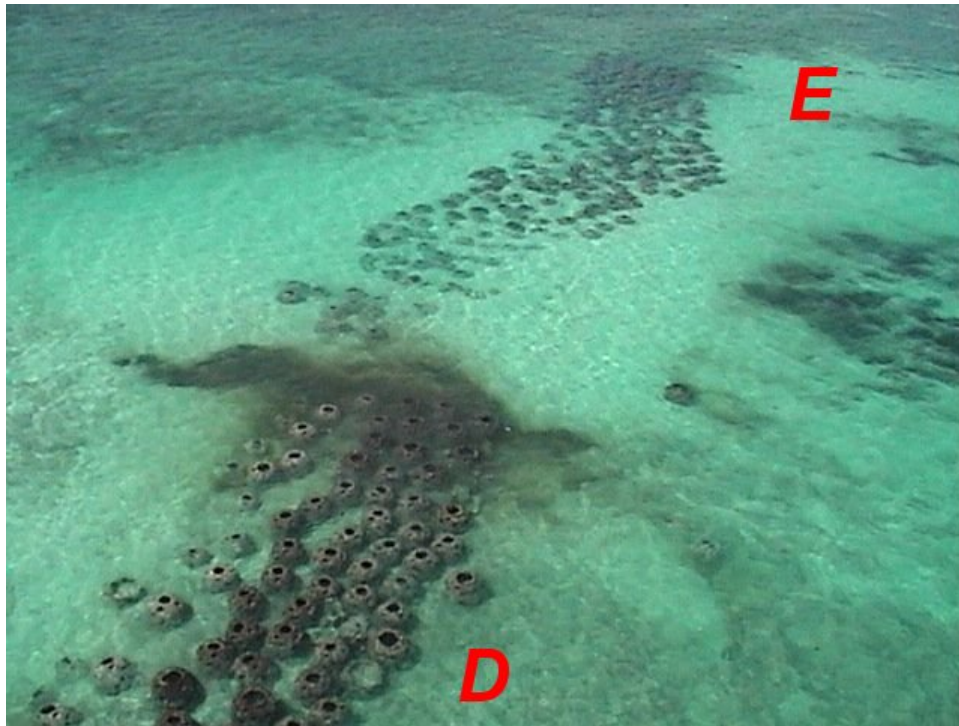
Figures 7 and 8 show that the Reef Ball breakwater regions C, D, and E did not survive well after impacted by Hurricane Ivan. A close-up aerial photograph of that area is shown in Figure 11. This breakwater portion was constructed after regions A and B, and inspection of the units indicates that the concrete quality, fabrication of anchoring sleeves, and anchoring was not satisfactory. Hence this part of the breakwater failed under the wave attack from the major hurricanes. Inspections revealed poor quality concrete, omission of the concrete additives, omission or unusable anchoring sleeves, and the resulting lack of any anchoring on most of the units in this region. This resulted in movement and breakage of many of the units in this area, as shown in the aerial photographs and Marenter survey.

**Figure 11. Aerial Photograph – Region D-E**

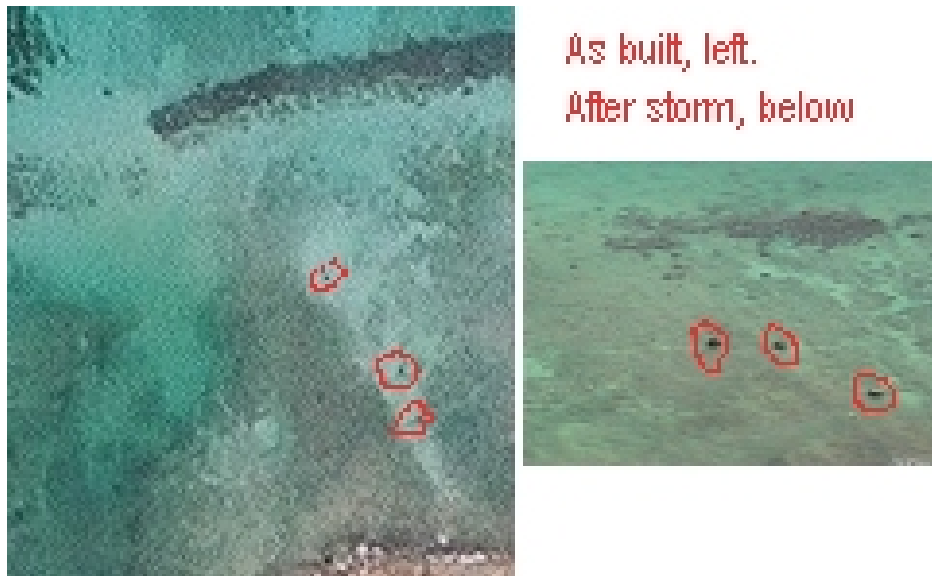
Another problem is the 3 units in the area between the shore and the breakwater in region D, as shown in Figures 5 and 7. Figure 12 shows that these 3 units were left in that position after construction and before Hurricane Ivan, as they are in the same locations both prior to and after being impacted by Hurricane Ivan. Note that in these aerial photographs, these 3 units are located on a sand shoal, which may have been the reason that they were not deployed out on the breakwater (the units may have run aground on the shallow sand shoal during deployment, and not able to be moved).

**Figure 12. 3 Reef Ball Units Shoreward of Region D in the As-built Photograph on the Right, and Post-Hurricane Ivan Aerial Photograph on the Left. Note the 3 Reef Ball units shoreward of the breakwater in both photographs, and the displaced units in the breakwater after Hurricane Ivan.**
