**Shoreline Response for a Reef Ball TM Submerged Breakwater System
Offshore of Grand Cayman Island**

A thesis submitted to
Florida Institute of Technology
in partial fulfillment of the requirements
for the degree of

Master of Science
in
Ocean Engineering

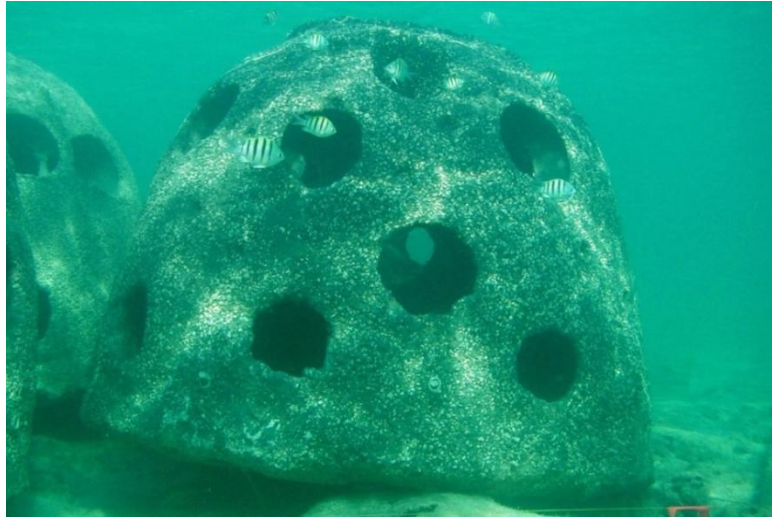
Figure 5. Reef Ball unit installed off Grand Cayman Island.
(Photo courtesy of Lee Harris)

One type of artificial reef unit recently used for submerged breakwaters is a permeable, hollow cement hemisphere known as Reef Ball™, shown in Figure 5. Reef Balls were originally designed as artificial reefs for biological enhancement, but uses have expanded to many other applications including shoreline stabilization, oyster growth, mangrove rehabilitation, and as marina protection (Reef Beach Company, Ltd., 2007). Precht (2006) states that “due to the combination of creativity and aptitude for ecological restoration, Reef Balls are increasingly popular with the marine tourism throughout the world.”

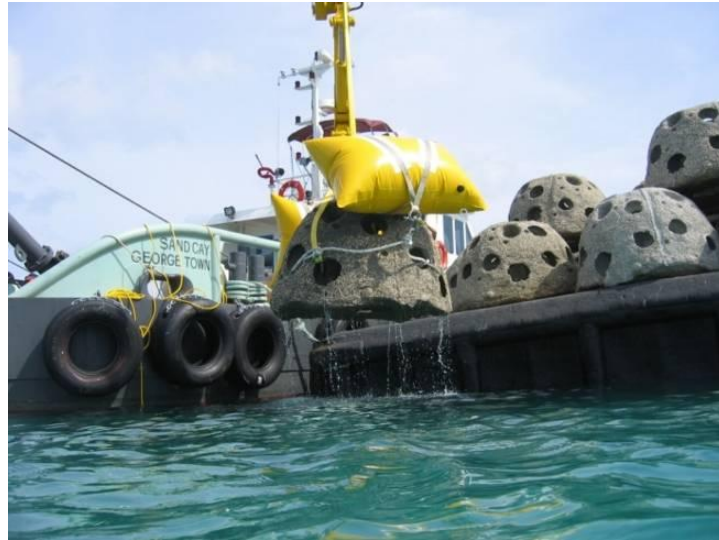
Figure 6. Reef Balls being deployed from a barge.
(Photo courtesy of Lee Harris)

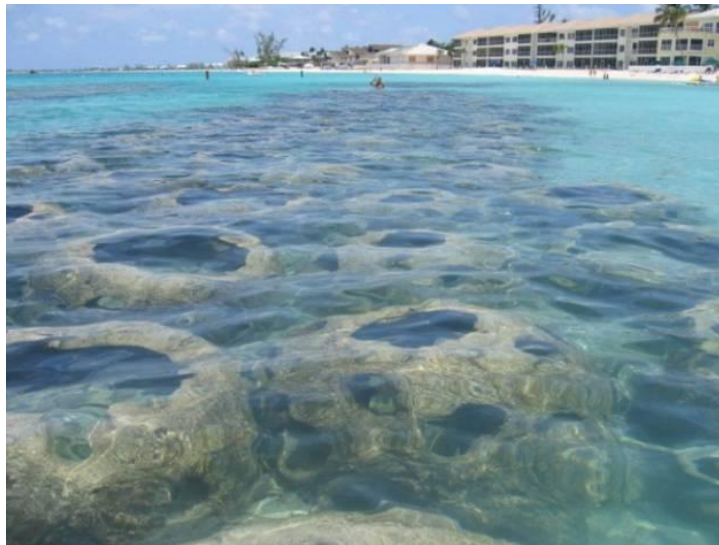
Figure 7. Reef Ball Breakwater after installation in Grand Cayman Island.
(Photo courtesy of Lee Harris)

locations. Figure 7 shows an example Reef Ball Breakwater after installation in Grand Cayman Island.

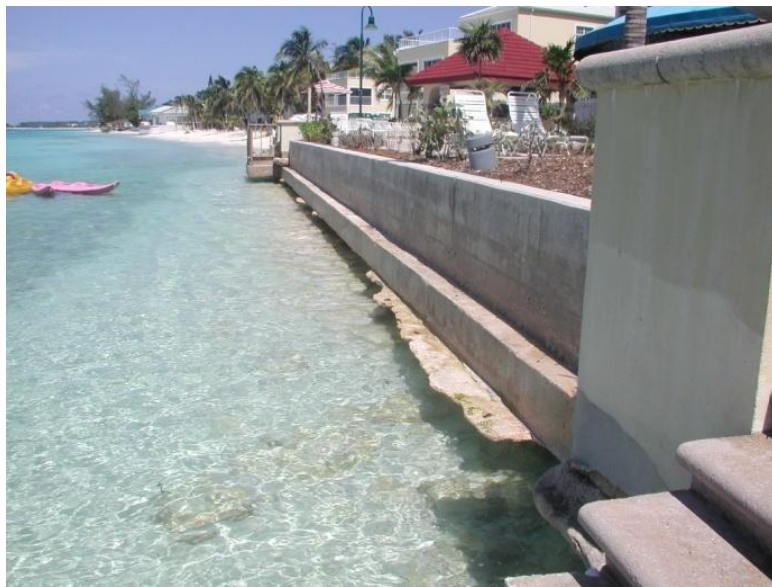
Figure 10. View looking to the North at Marriott seawall in 10/02.
(Photo Courtesy of Lee Harris)

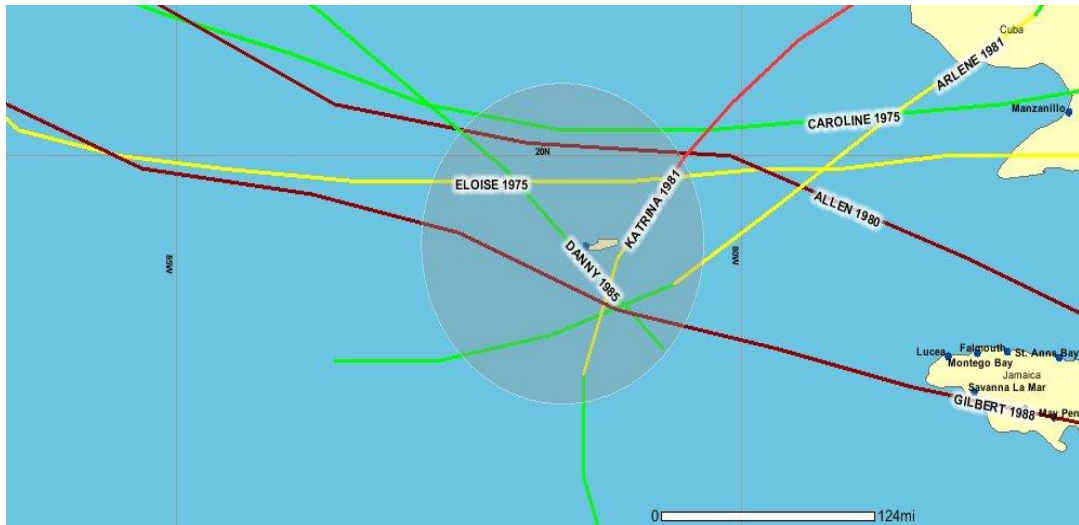
Figure 14. Hurricane and Tropical Storm paths near Grand Cayman. From 1971 to 1989. Note the majority of storms approaching Grand Cayman from the East. (NOAA Coastal Services, 2008)

As seen from Figures 14 and 15, the frequency of hurricanes and tropical storms approaching from the southwest has increased in recent years. Figure 14 shows the hurricane and tropical storm paths between 1971 and 1989. The majority of the storms approach Grand Cayman from the east or southeast. When storms and hurricanes approach more from the east, Seven Mile Beach is on the leeward side of the wind and waves. From 1990-2007, the storms switched from approaching from the East and Southeast to the Southeast and Southwest, as shown in Figure 15. The number of storms has also increased, producing strong winds and waves that affect Seven Mile Beach.

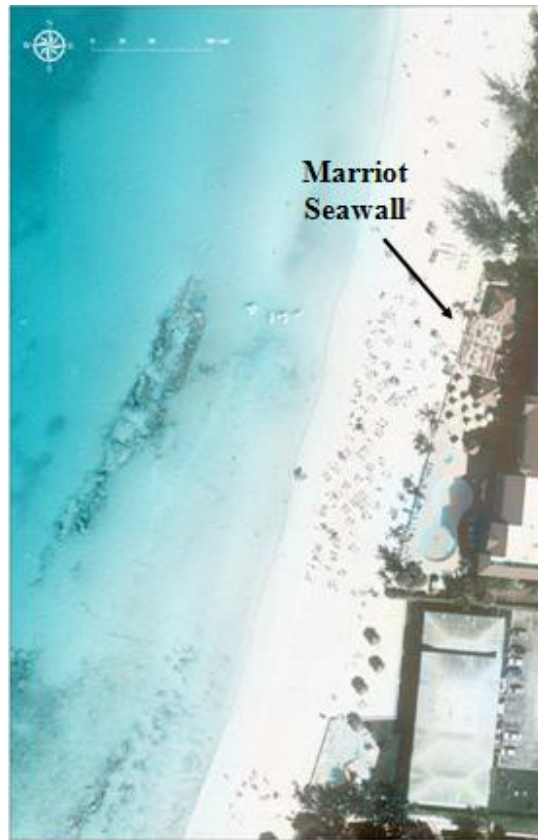
Figure 16. Aerial image from 1994 showing location of Marriott Seawall and width of beach in front of the seawall.

Seawalls are typically built on shorelines that are already eroding to protect upland structures. This is not the case for the Marriott Hotel seawall. When the Marriott Hotel was constructed in 1989, the pool and deck were constructed seaward of the hotel, but landward of a wide sand beach. When the beach eroded, the deck wall acted as a seawall when exposed to wave attack. Figure 16 shows that the beach was still very wide (approximately 100 feet) five years after the construction of the hotel. It was not until the early 2000's that the beach would recede enough to have waves directly impact the seawall to accelerate or increase in the erosion. In a memo sent to the Marriott evaluating the effects of the existing seawall, Harris (2002) states that even if the seawall had not been constructed there would still be an erosion problem that would not be solved if the seawall was removed.

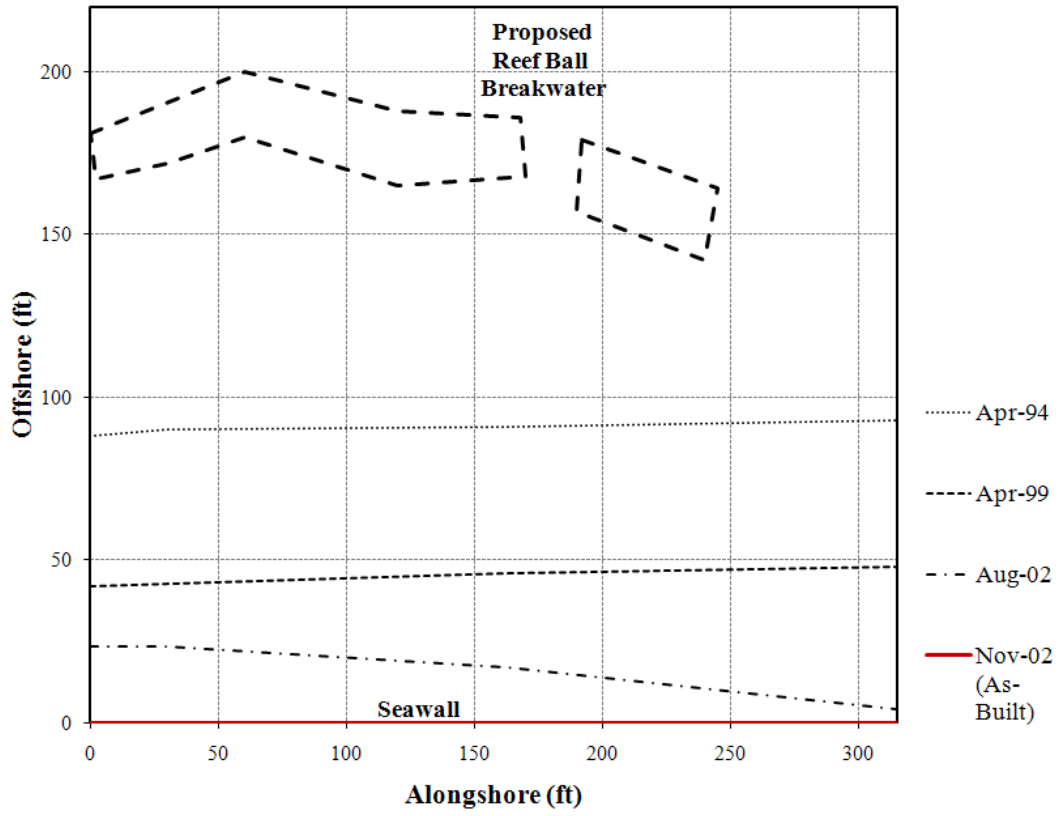
Figure 23. Location of shoreline from 04/94 to 11/02 (pre- breakwater installation).

Pre-breakwater installation shorelines are displayed in Figure 23. In 1994 the beach width was the greatest at 90 feet. The shoreline continued to retreat until 8 years later, the shoreline reached the seawall. Post-breakwater installation shorelines are displayed in Figure 24. In 11/02, the beach width was zero feet. Three-months after installation, the shoreline accreted an average of 50 feet. The narrowest beach width was in 11/04 following Hurricane Ivan. In 02/07, four years after the project, the middle of the beach reached 82 feet wide, almost as wide as the 1994 beach. Between an average of 50 and 70 feet of beach width occurs during the winter/spring, decreasing to 10-20 feet in the fall following tropical storm events.

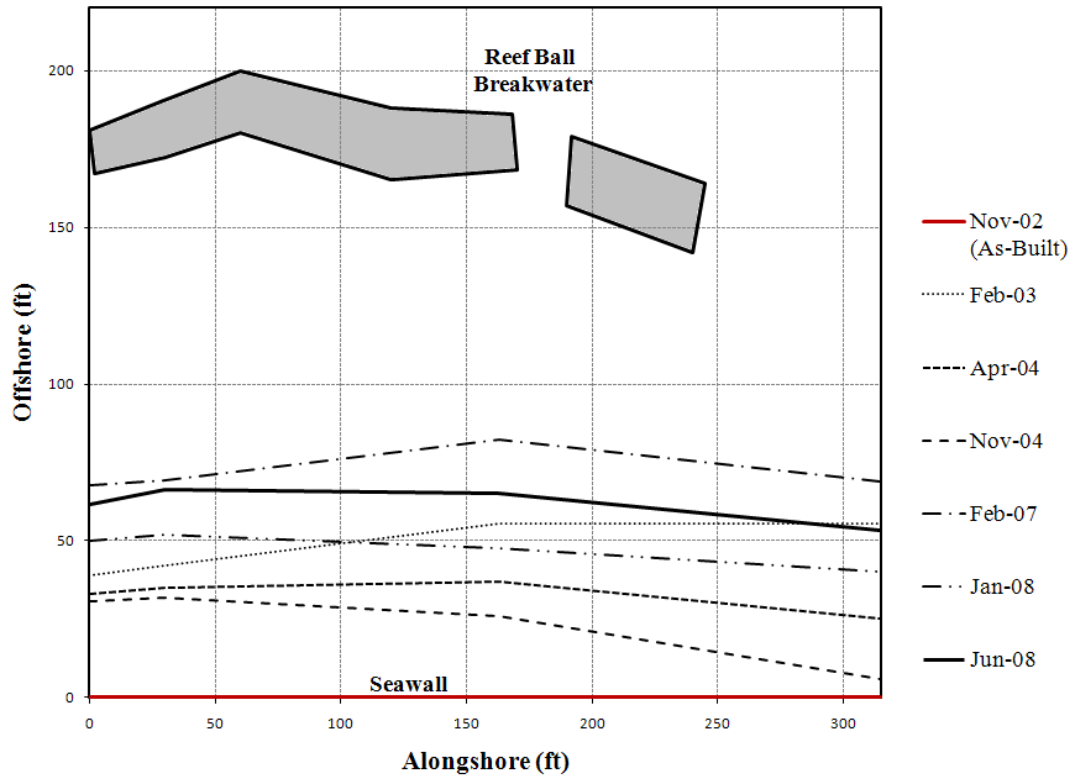
Figure 24. Location of shoreline from 11/02 to 06/08 (post-breakwater installation).

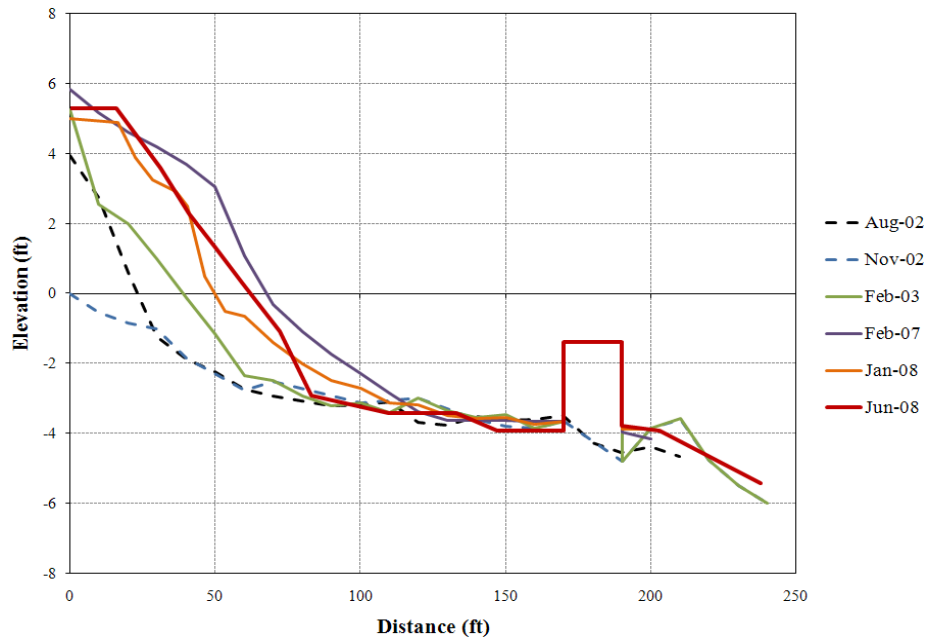
Figure 26. Cross-shore positions for PL 1 (South end of breakwater). The dashed lines represent pre-breakwater and the solid lines represent post-breakwater construction.

Between 2003 and 2007, the largest elevation and berm width increase on the shoreface is seen in all profile lines. Elevations at the seawall increased 1 to 2 feet. The berm height (+2 to +3 feet) and width (+20 to +30 feet) also increased significantly. From 2007 to 2008, the profiles steepened back to the before extension and beach fill period, presumably reaching equilibrium. Two and a half years after the beach fill (06/08), the beach width and height is still greater than two years before the fill in 02/03.

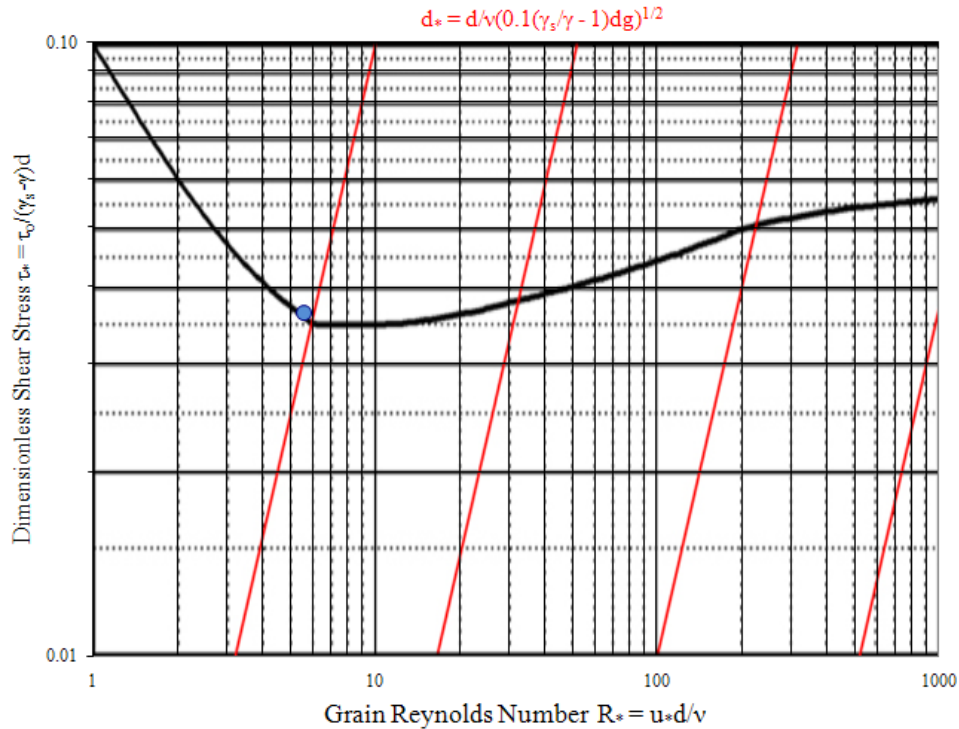
Figure 35. Shields diagram showing variables required for sediment transport.

The Shields diagram was used to determine the horizontal water particle velocity required for sediment movement. A boundary shear stress of 0.165 lb/ft-s^2 produces a grain Reynolds number and Shields parameter of 6, and 0.04, respectively, shown in Table 14. As shown in Figure 35, this boundary shear stress is required to move the sediment found in front of the Marriott Hotel.

Variable		Symbol	Units
Boundary shear stress	0.165	τ_o	lb/ft-s ²
Grain Reynolds Number	6	R_*	N/A
Shields parameter	0.04	τ_*	N/A
Velocity	0.91	U	ft/s

Using Equation 20, the minimum horizontal velocity required for sediment movement is 0.91 ft/s. The horizontal water particle velocity results from the H_t determined from the Friebel and Harris method were compared to the minimum velocity required for sediment movement. For a wave period of 4 seconds, sediment should not move under non-storm conditions, as seen in Table 15. Bold numbers indicate theoretical sediment movement. Tables 16, 17, and 18 show that sediment should begin to move for a wave height of three feet and a wave period of

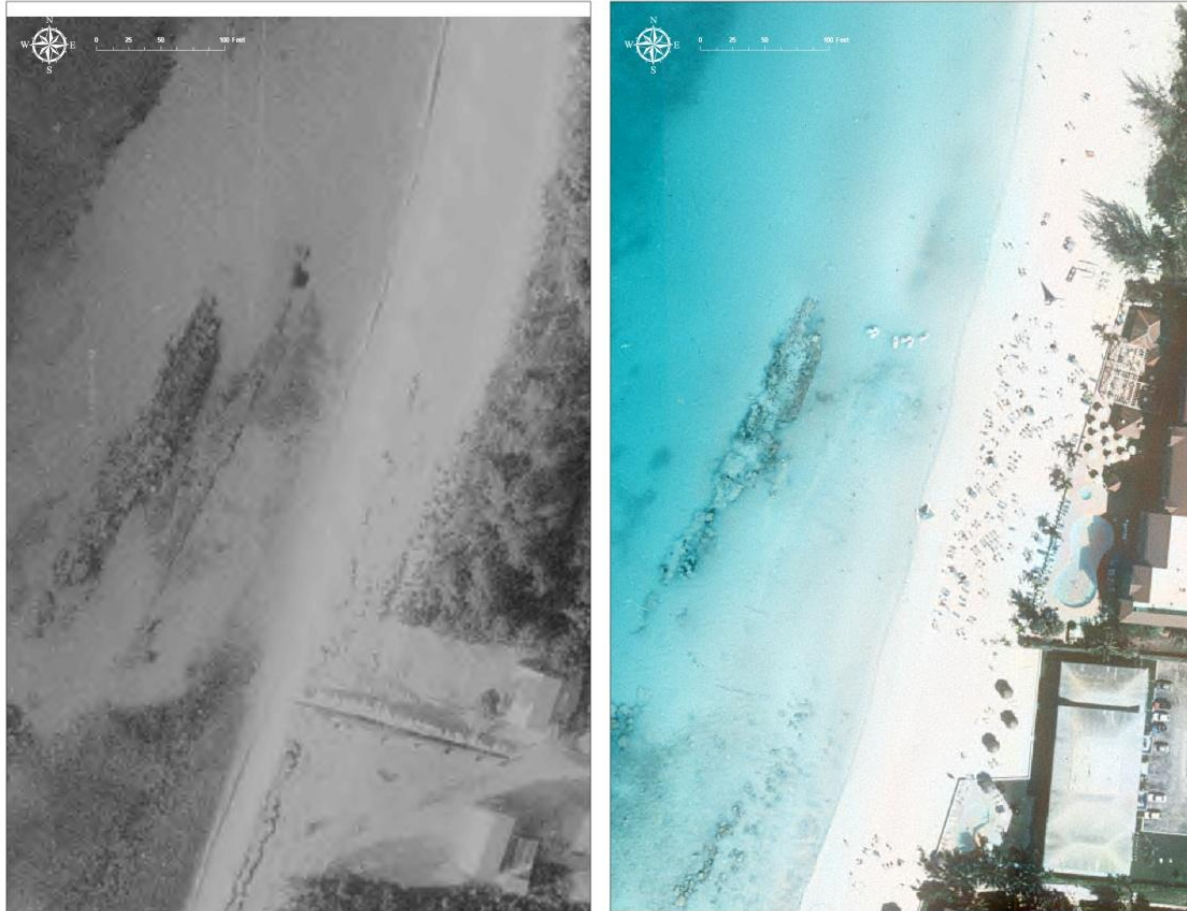
Figure C-1. Aerial photographs for 1972 and 1994
(from right to left)
(Photo Courtesy Tim Austin, Cayman Islands Department of Environment)

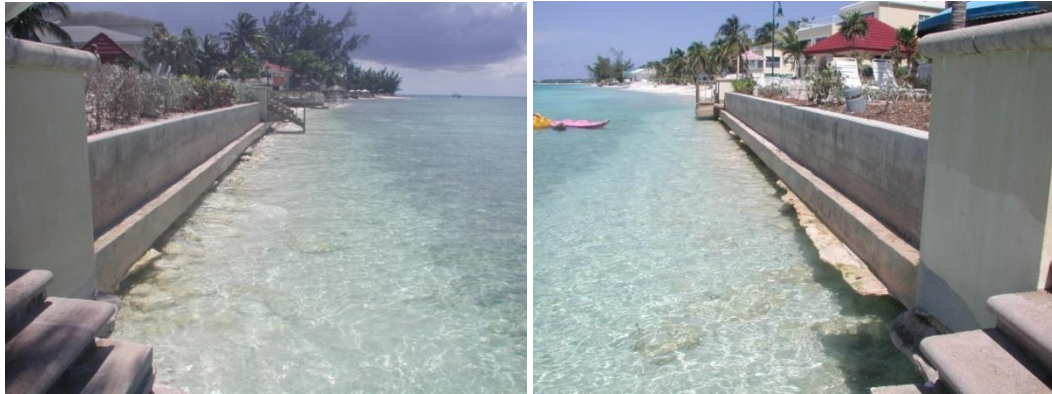
Figure C-4. View looking to the South and North at seawall in Oct. 2002

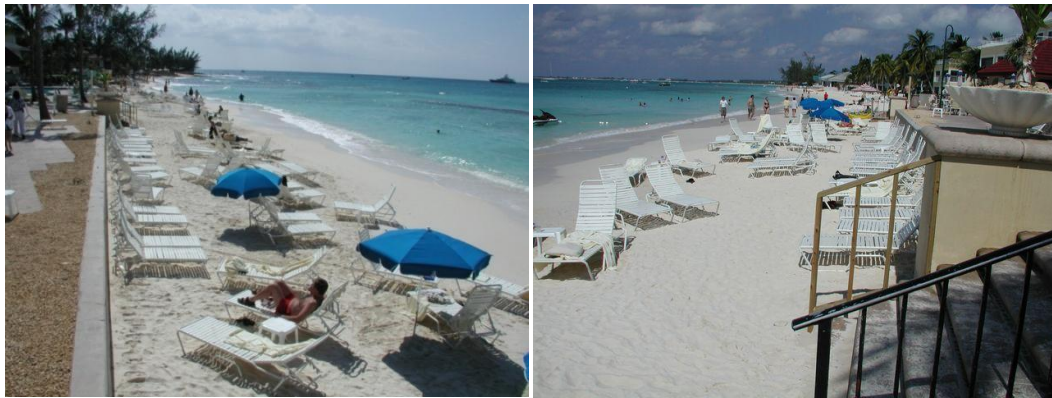
Figure C-5. View looking to the South and North at seawall in 02/03.

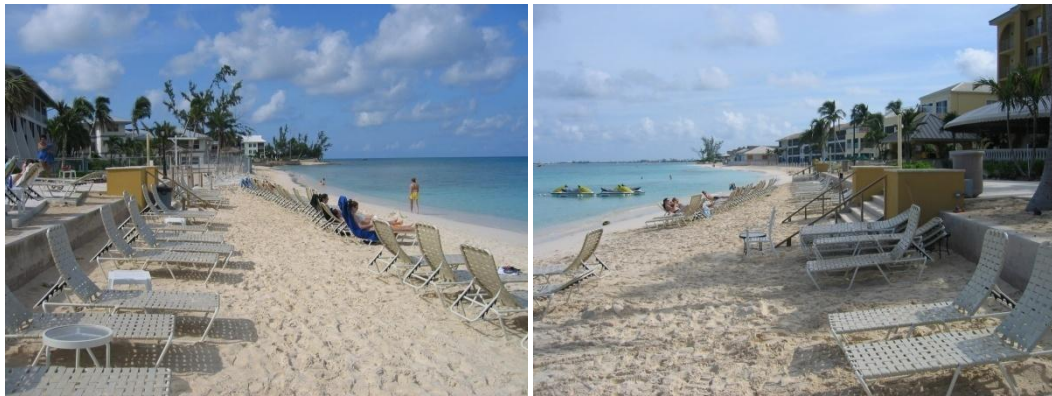
Figure C-6. View looking to the South and North at seawall in May 2005.
(All photographs courtesy of Lee Harris)

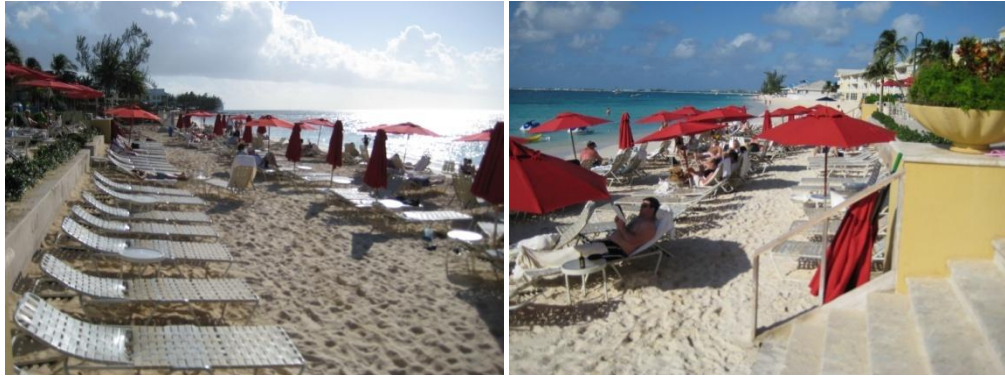
Figure C-7. View looking to the South and North at seawall in 01/08.

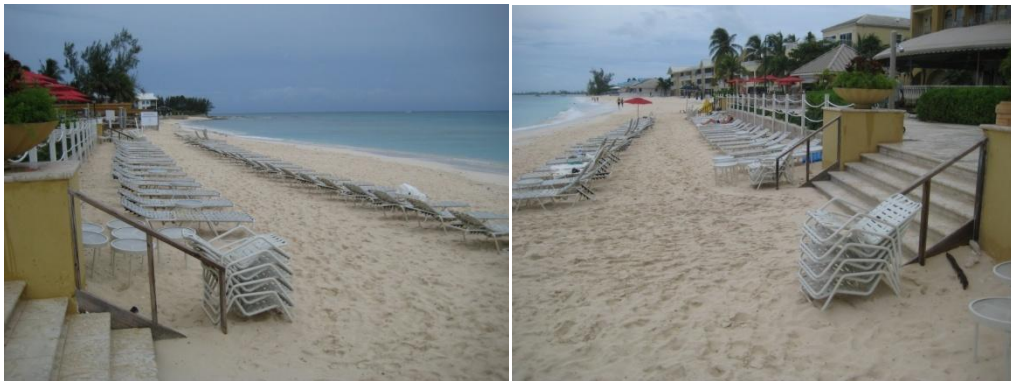
Figure C-8. View looking to the South and North at seawall in 06/08.

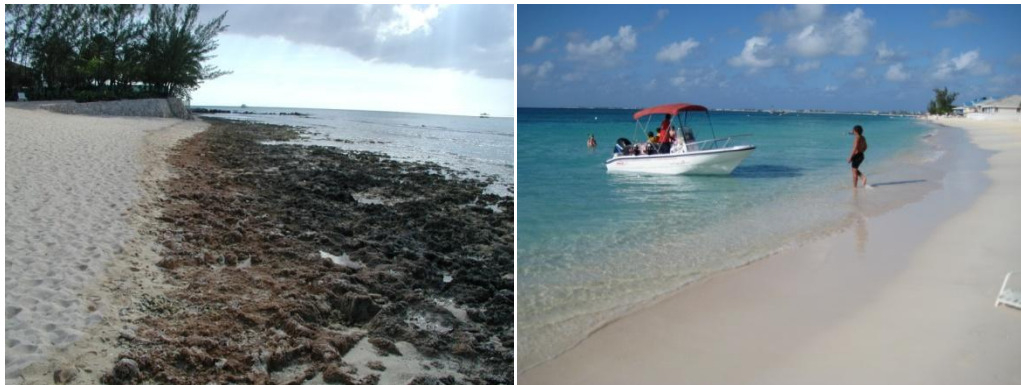
Figure C-9. Example of rocky shoreline to the south (02/03) and boat docking to the north (01/08) of the Marriot Hotel.
(All photographs courtesy of Lee Harris)
