STATUS REPORT FOR THE SUBMERGED REEF BALL™ ARTIFICIAL REEF BEACH STABILIZATION PROJECT FOR THE GRAND CAYMAN MARRIOTT HOTEL

performed by Lee E. Harris, Ph.D., P.E.
Consulting Coastal Engineer
Assoc. Professor of Ocean Engineering
Florida Institute of Technology
Melbourne, Florida 32901 USA

July 2002

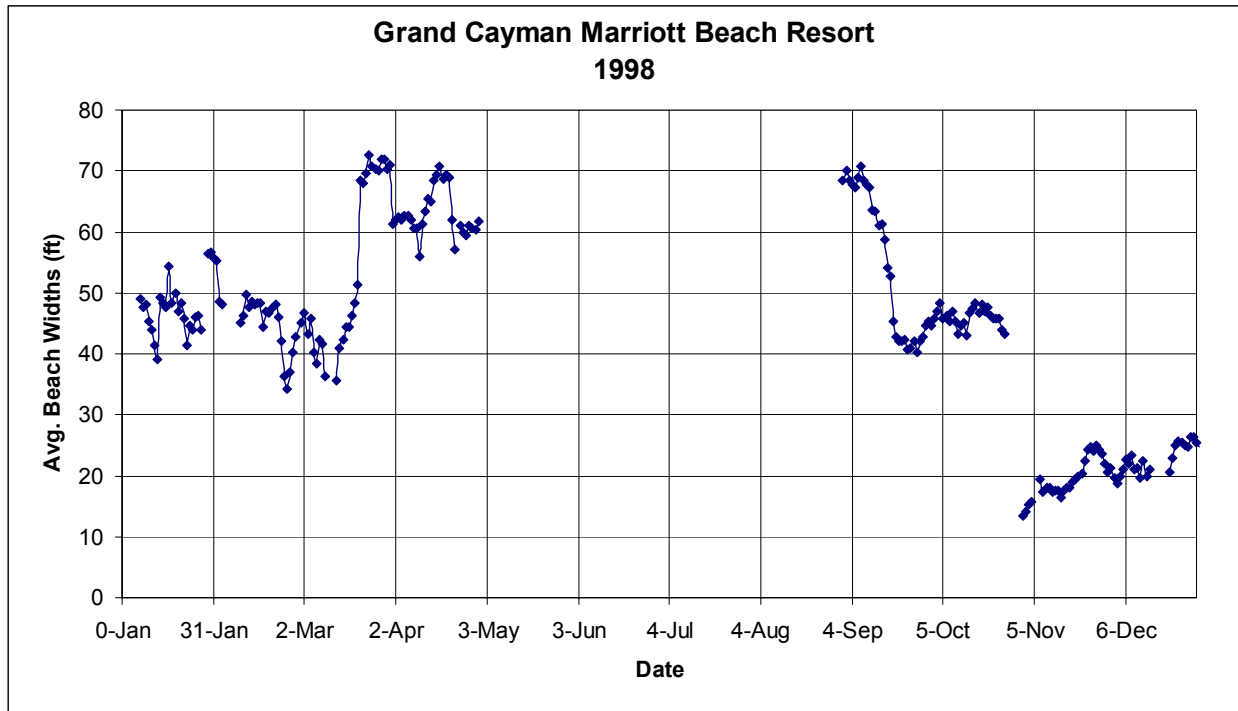
The Grand Cayman Marriott Resort has experienced beach erosion. The existing beach width varies seasonally and with storm events, and although it does begin to recover by sand transport into the area from the north, the beach continues to be eroded away by waves coming from the southwest each fall. The staff at the Marriott measures the beach width from the seawall at the north, center and south end of the property every day, with this information providing a good record of beach changes, and should be continued to be collected. These data are shown in the graphs below for the variation in the average beach width in front of the Marriott over time:

Note that these graphs show that there are seasonal changes in the beach width, but prior to the installation of the Reef Ball breakwater at the end of 2002, the beach width was decreasing each year. In 2002 the maximum beach width was only 45 feet and the minimum width was zero, and the zero beach width occurred over a much greater time period than in prior years. Following the installation of the Reef Ball breakwater (completed at the end of 2002) the data to date for 2003 show that the beach width reached a width in excess of 60 feet, with the minimum width of 25

feet. The fall tropical storm and hurricane season has the narrowest beach widths, which may reduce the existing beach width further.

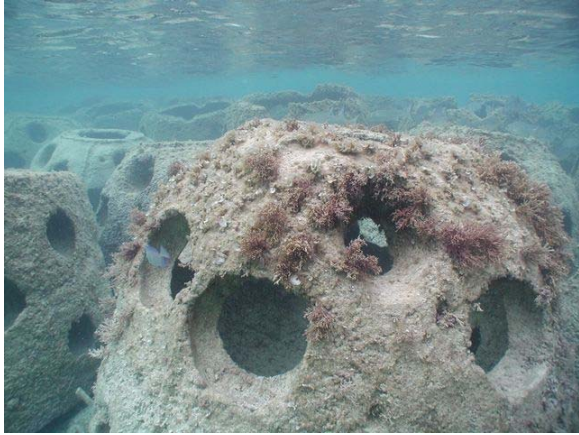
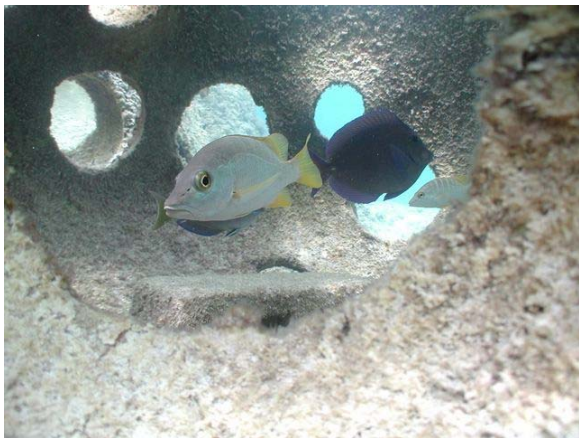
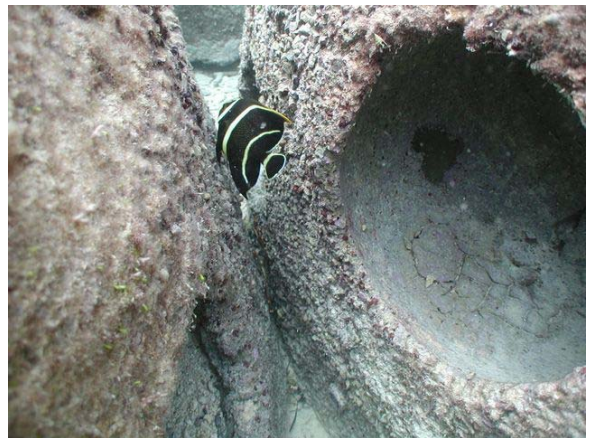
The underwater photographs below show the condition of the Reef Ball units. After only 3 months, there is considerable marine growth on the Reef Ball units and several species of fish in and around the artificial reef units. Note that some of the Reef Ball units had to be fabricated shorter than the standard size, due to the shallower water depths at the south end of the breakwater.

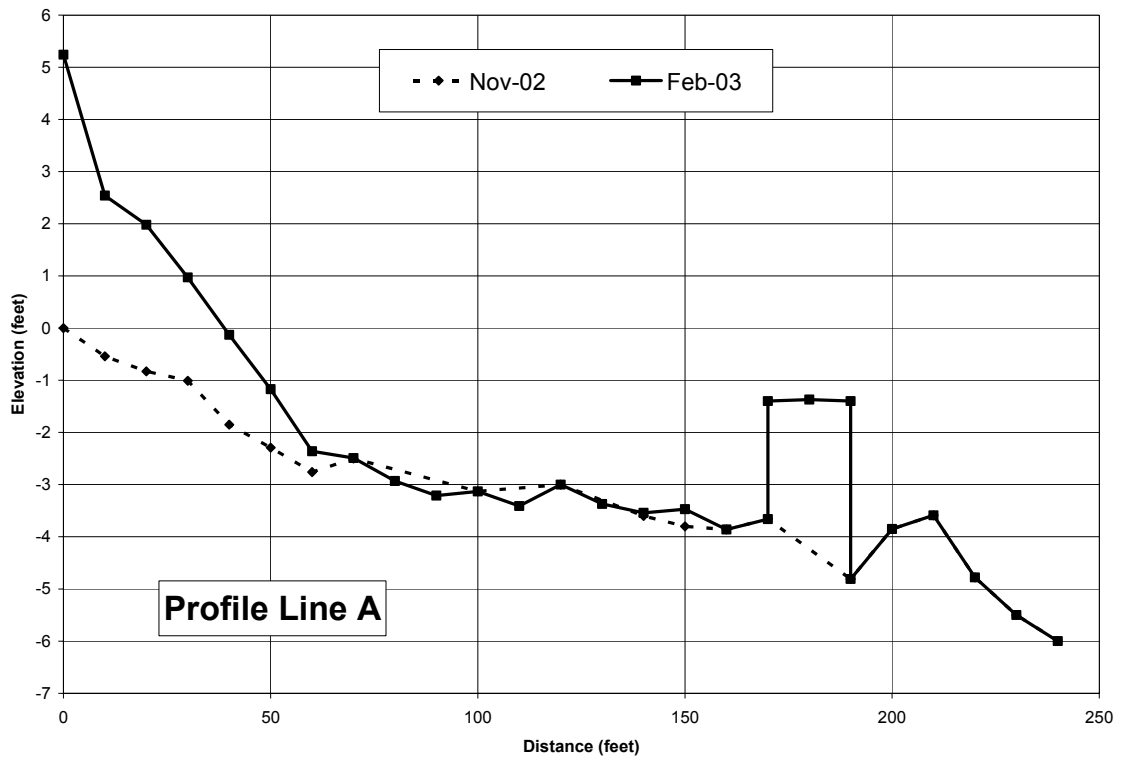
Profile Line A – Across South End of Reef Ball Breakwater

Surveys were performed in February 2003 which document the beach condition after 3 months, and are compared with the beach condition immediately following the completion of the Reef Ball breakwater in November 2002, as shown in the Figures below for the 3 profile lines at the south end of the Marriott.

These graphs below show the additional sand that accreted seaward of the Marriott seawall following the installation of the Reef Ball breakwater. The beach width increased from zero to 40 to 55 feet in width from November 2002 to February 2003, whereas the widest beach width in all of 2002 was 45 feet. Recent wave action has reduced the beach widths to 25 feet at the Marriott (but even less at adjacent beaches in the area), and the current tropical storm and hurricane season may further erode the beach. However, the completed Reef Ball breakwater (and extension if added) is designed to minimize the beach erosion and assist with the stabilization of the beach at the Marriott.
