Project Name: **Reef Ball™ Submerged Artificial Reef Breakwater
Marriott Resort, Grand Cayman, Cayman Islands**

Work performed: Feasibility study for beach stabilization, with development of alternatives. Engineering design, permitting, and construction supervision of submerged artificial reef breakwater.

Status: Project completed, current feasibility study for expanding the project north and south.

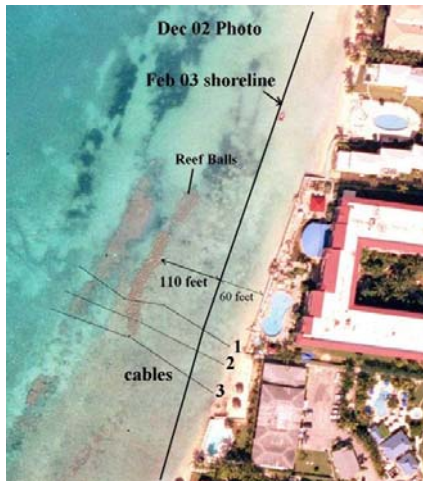
Aerial photograph (above left), 5-row Reef Ball™ breakwater viewed above water (above center) and underwater (above right), beach in 2002 before the project (below left), and in February 2003 after the project (below center), and in February 2007 (below right).

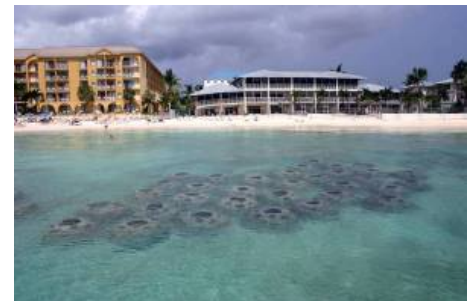
In 2001 Dr. Harris was contacted by Columbia-Sussex Corporation, then owners of the Grand Cayman Marriott Resort, to perform a site visit and a feasibility study for methods to stabilize the eroding beaches. This study was completed and several alternatives were presented, with the owners electing to construct a submerged artificial reef breakwater using Reef Ball™ units. Dr. Harris then proceeded to develop the design for the submerged breakwater, with permit applications submitted to the Cayman Islands (CI) Department of the Environment (DOE). Dr. Harris made presentations to the DOE staff, and accompanied the Minister of the Environment and DOE staff to a site visit of similar successful projects by Dr. Harris in the Dominican Republic. The breakwater was constructed in 2002, with an extension to the south completed in 2004. All of the reef units have remained stable during waves from major hurricanes, including the direct hit by Category 5 Hurricane Ivan that devastated Grand Cayman in 2005 and large waves from Category 5 Hurricane Wilma (photo on the right after Hurricane Ivan shows the breakwater and beach with no damages, but damages to an upland building which forced its demolition). The beach continues to have seasonal variations in width, but unlike the complete lack of beach 50% of the time prior to this project, the beach has been stabilized.
