## Submerged Reef Structures for Habitat Enhancement and Shoreline Erosion Abatement

by Lee E. Harris, Ph.D., P.E.

**Purpose:** This Coastal and Hydraulic Engineering Technical Note (CHETN) presents the use of submerged artificial reef structures as submerged breakwaters, providing both wave attenuation for shoreline erosion abatement, as well as artificial reef structures for habitat enhancement. An example of this technology is presented for a project constructed using Reef Ball™ artificial reef units (shown in Figure 1) along the southern shore of the Dominican Republic near Bayahibe (east of Santo Domingo and LaRomano, as shown in Figure 2) during the summer 1998.

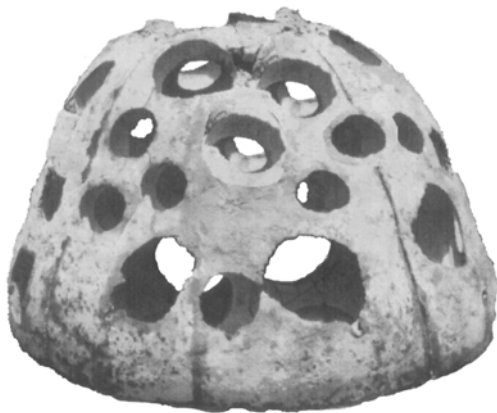
Figure 1. Individual Reef Ball™ Unit.

**Introduction:** Approximately 450 Reef Ball™ artificial reef units were installed offshore of the Gran Dominicus Resort during the summer 1998 to form a submerged breakwater for shoreline stabilization, environmental enhancement and eco-tourism. The individual units used for the breakwater were 1.2m high Reef Ball™ units and 1.4m high Ultra Ball units, with base diameters of 1.8 meters. Figure 1 shows an individual Reef Ball™ unit, which is fabricated to provide void spaces and surface areas for habitat and biological growth. These artificial reef units were deployed by using large buoys inside and strapped to the Reef Ball™ units to float the individual units offshore and set them in place by divers.

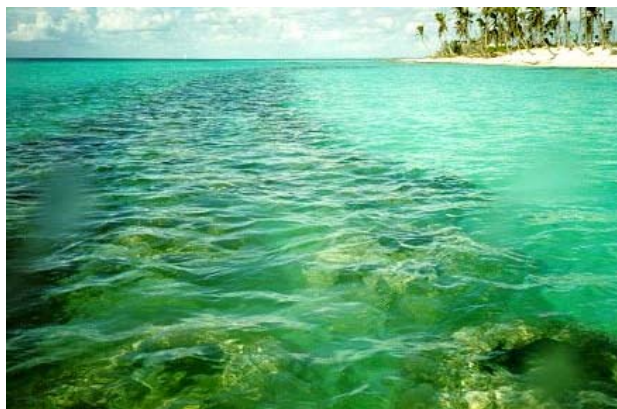
**Figure 3. Three-Row Submerged Breakwater. Figure 4. April 2001 Aerial Photograph.**

The design of the submerged breakwater system consisted of three segmented breakwater sections, using three rows of Reef Ball™ units for each segment (Figure 3 and 4). The breakwater was installed in water depths of 1.6m to 2.0m, so that the units were 0.2m to 0.8m below the mean water level (the tide range in the project area is approximately 0.4m).

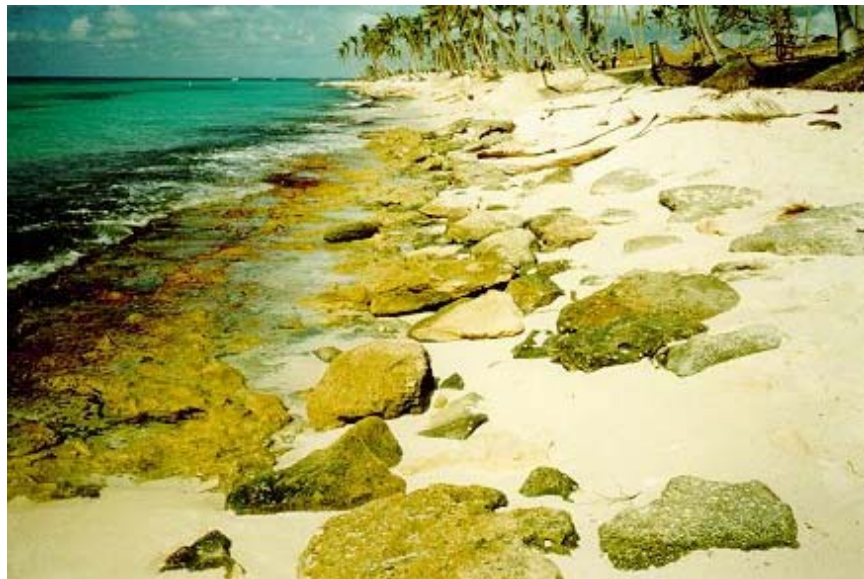
**Figure 5. Eroded Beach and Shoreline following Hurricane Georges and Mitch.**

**Shoreline Conditions after Hurricane Impacts:** Comparison of photographs taken before and after the installation of the Reef Ball™ artificial reef submerged breakwater show that sand had accreted and the beach was building prior to Hurricane Georges. The storm surge and wave conditions accompanying this category three hurricane greatly exceeded the levels for which the submerged breakwater can provide wave attenuation and shoreline protection, so that significant erosion of the beach and dune occurred, as shown in Figure 5.

A submerged breakwater becomes ineffective during severe storm surge conditions accompanying hurricanes. Hurricanes Georges and Mitch produced meteorological and oceanographic conditions that created elevated water levels due to the storm surge and waves. On top of this storm surge, the large waves and strong currents accompanying the hurricanes produced severe erosion of the shoreline, with large volumes of beach sand washed away, leaving a one to two meter high escarpment which undermined several palm trees in the project area and adjacent beaches to the east. As depicted in Figure 5, the shoreline that had been sand prior to the hurricanes became an exposed rock ledge.

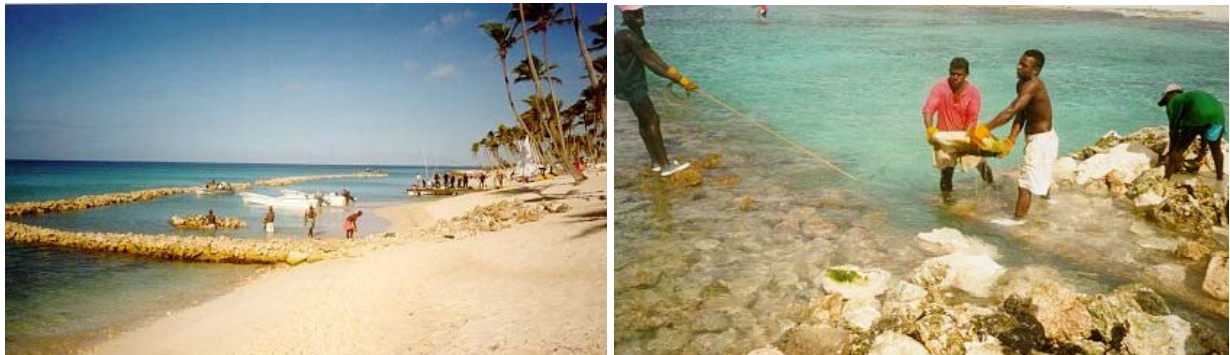
**Figure 6. Placement of Small Rocks on top of Submerged Reef Ball™ Breakwater.**  
Photograph taken in February 1999 during construction.

During the winter of 1999 Gran Dominicus added a small quantity of sand to the beach, and placed a considerable amount of small rocks on top of the submerged Reef Ball™ breakwater, raising the crest elevation above the water level, as shown in Figure 6. These photographs show that contrary to the recommendations of the engineering consultant, small rocks were used instead of larger rocks that would be stable under wave attack, and that in addition to widening and raising the elevation of the breakwater above the water level, rocks were added to connect the eastern end of the breakwater to the shore. The shoreline attachment prevents alongshore sediment transport, which is undesirable. Due to small sizes of the rocks that were added to the breakwater, wave action easily displaced these rocks, scattering them landward of the original breakwater. Figure 7 shows an aerial photograph that delineates the original Reef Ball™ breakwater from the scattered smaller rocks.

**Project Performance:** The small rocks placed on top of the Reef Balls™ were moved landward of the breakwater by wave action shortly after they were placed, so that the submerged breakwater system was restored to its original configuration, except for the scattering of the small rocks landward of the breakwater (these small rocks were subsequently removed to regain the swimming area).

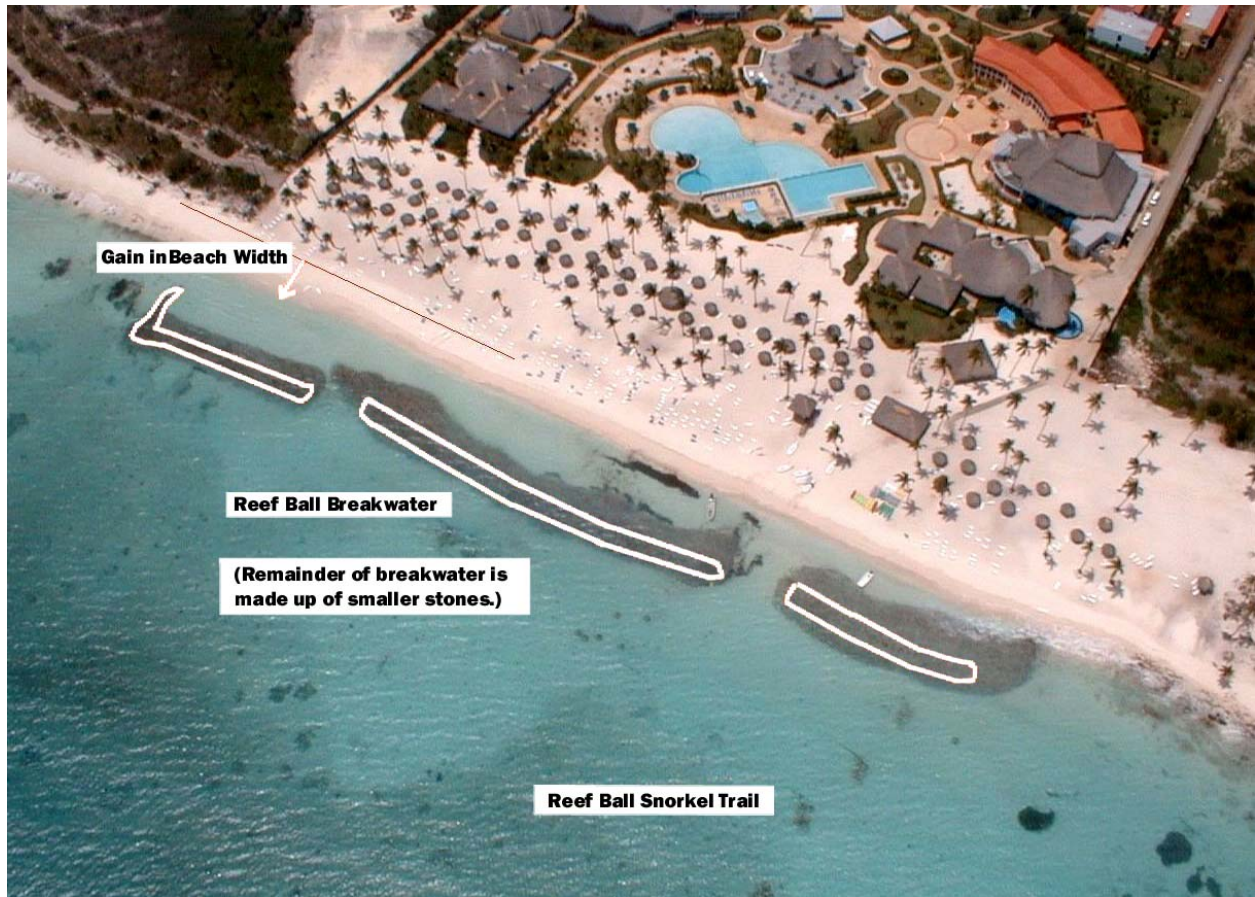
**Figure 7. Delineation of the Original Reef Ball™ Breakwater and Small Rocks.**  
Aerial photograph taken April 28, 2001.

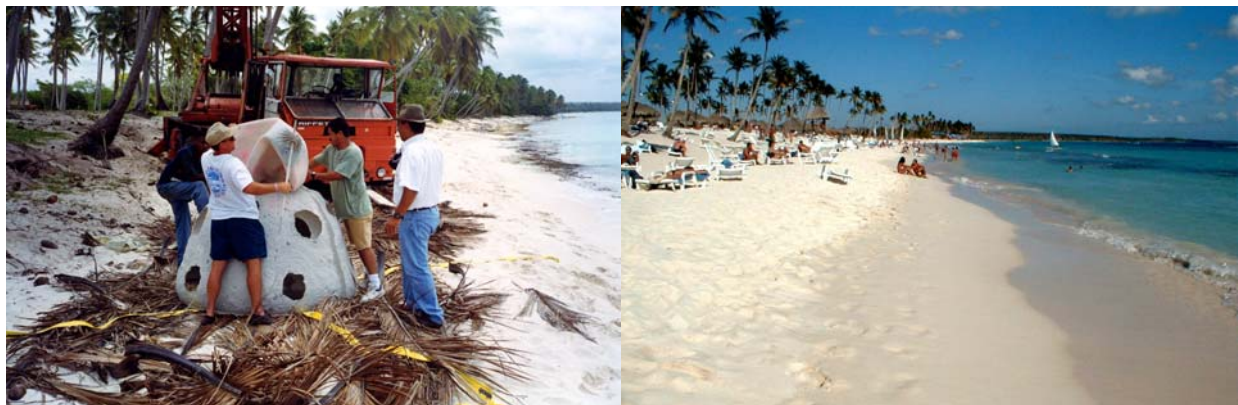
**Figure 8. Increased Beach Width at Project Center - looking east.**  
Summer 1998 (left) compared with April 2001 (right)

The comparison photographs in Figures 8 through 10 show that the Reef Ball™ breakwater has been very effective in assisting with the stabilization of the shoreline, with a significant increase in beach width and elevation along the Gran Dominicus shoreline. With a net littoral drift towards the west, no adverse effects have occurred on adjacent beaches, as these beaches have also accreted sand and recovered after the hurricanes in 1998, but not as much accretion as in the beach and shoreline area protected by the submerged artificial reef breakwater.

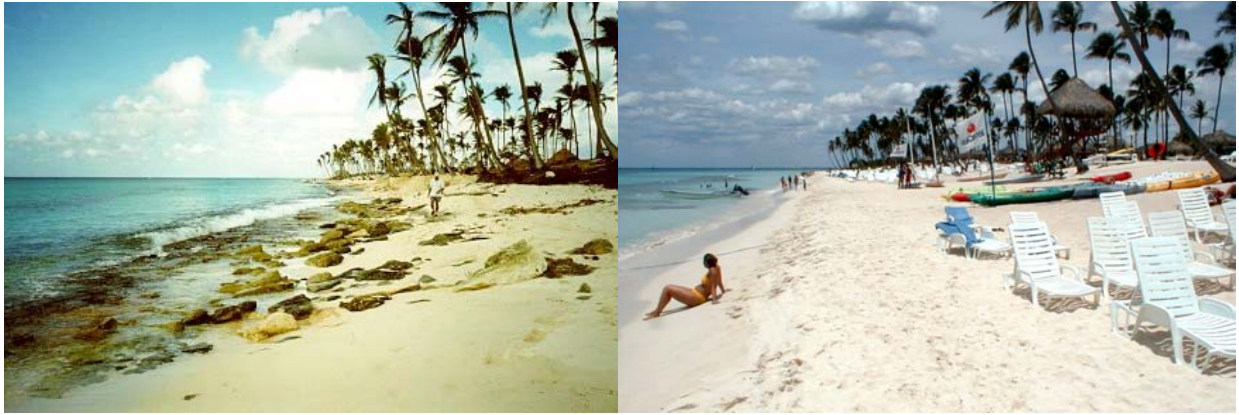
**Figure 9. Increased Beach Width at Eastern End - looking west.**  
November 1998 (left) compared with April 2001 (right)

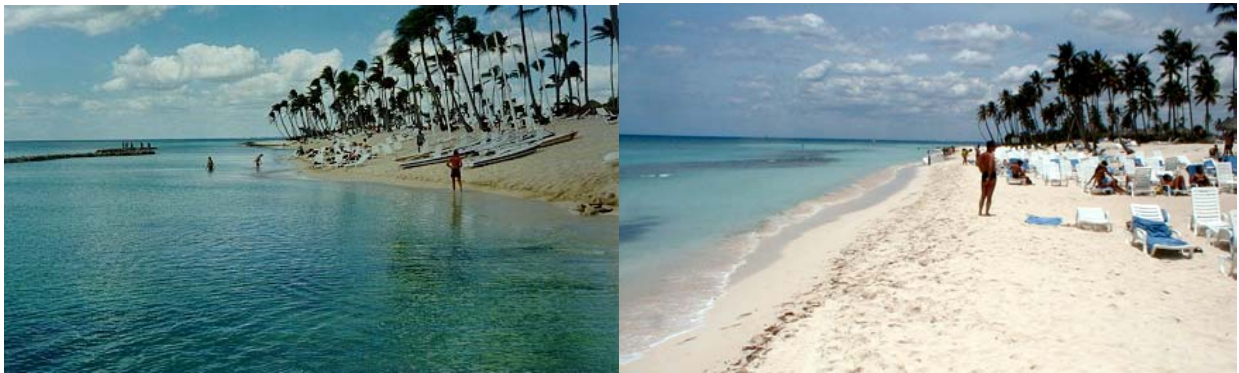
**Figure 10. Increased Beach Width at Center Project - looking west..**  
February 1999 after small rocks added on top of breakwater (left),  
compared with April 2001 showing large natural accretion (right).

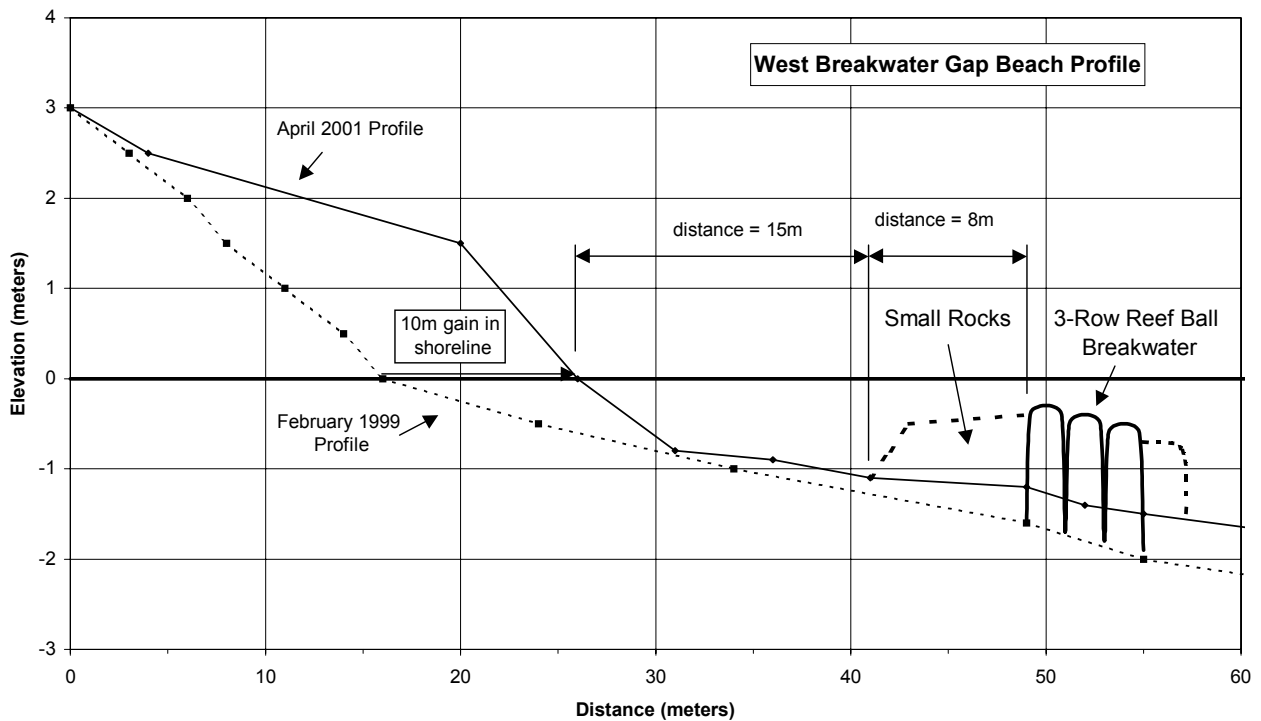
**Figure 13. Western Survey Profile across Breakwater near West Gap.**

The two graphs in Figures 13 and 14 clearly show sand accretion landward of the submerged breakwater system, with a 10m shoreline advance at the western profile line and 13m shoreline advance at the eastern profile line. Only a minimal amount of sand fill was added to the beach, with almost all of the sand gain due to natural accretion in the lee of the breakwater system.

Figure 15 shows the area immediately east of the project, where Phase 2 of the Gran Dominicus Resort is planned. Comparisons between these three graphs in Figures 13 to 15 clearly show that the beach has gained a considerable amount of sand and the shoreline has advanced significantly in the project area, but has remained stable to slightly accretionary on the adjacent beaches.

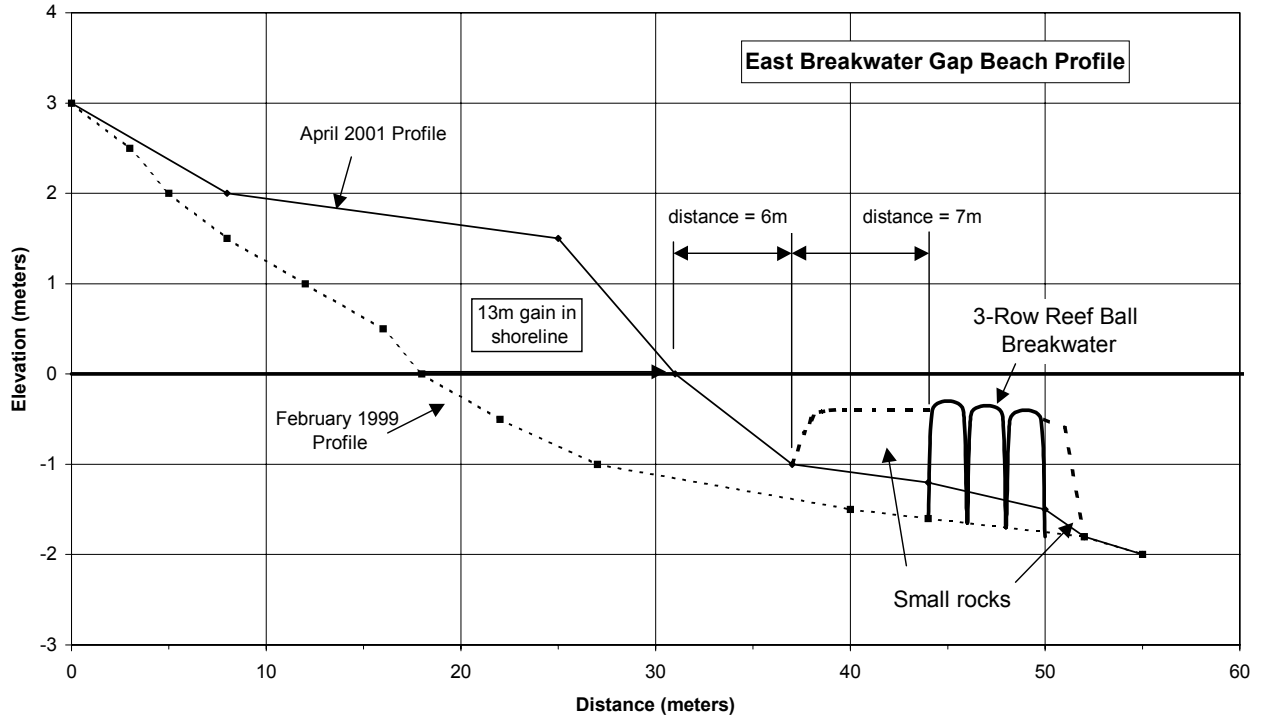
**Figure 14. Eastern Survey Profile across Breakwater near East Gap.**

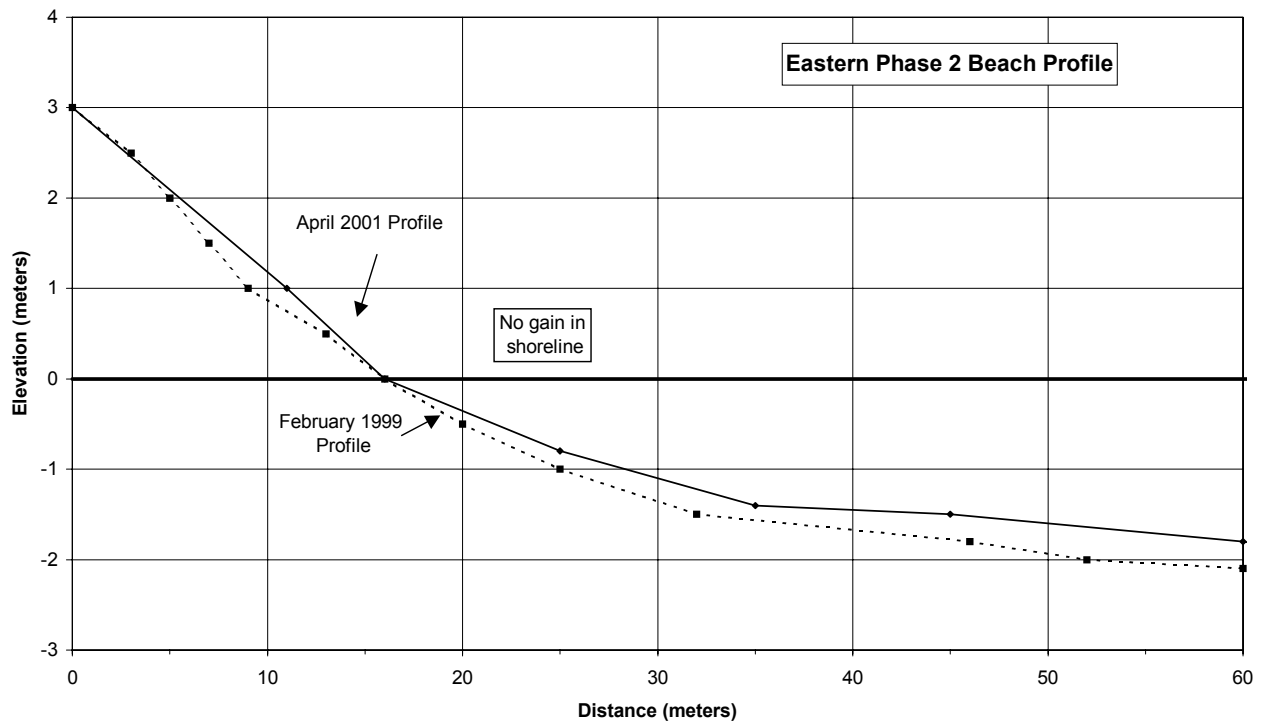
**Figure 15. Survey Profile East of Breakwater.**
