# POST HURRICANES EVALUATION OF THE SUBMERGED REEF BALL BREAKWATER AT THE MAYAN PALACE RESORT, QUINTANA ROO, MEXICO

Performed by: Dr. Lee E. Harris, Ph.D., P.E.  
Consulting Coastal-Ocean-Civil Engineer and Physical Oceanographer  
Associate Professor of Ocean Engineering & Oceanography  
Division of Marine & Environmental Systems  
Florida Institute of Technology  
Melbourne, FL 32901 USA

Performed for: Lic. Mario Chacon Ramos  
Marenter, S.A. de C.V.  
Cancun, Q. Roo, Mexico

October 2005

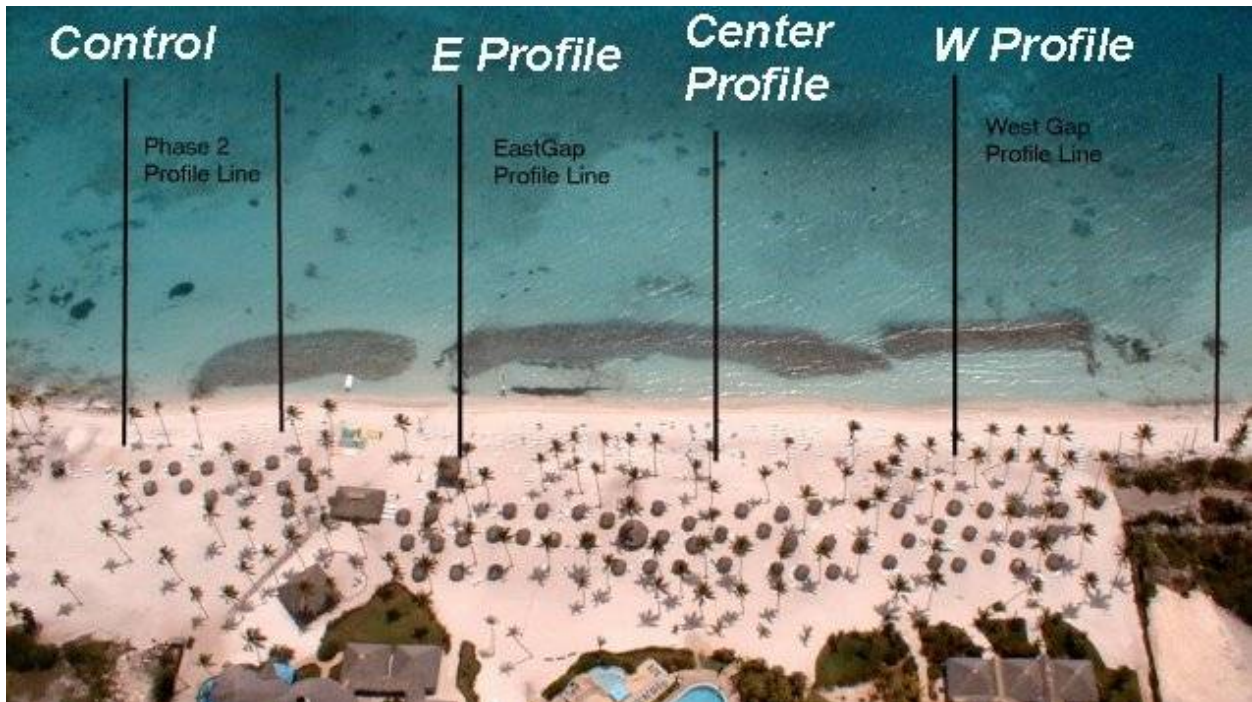
The aerial photograph shown in Figure 1 shows a monitoring survey layout example for the 6 profile lines surveyed over a 300m shoreline length (approximately 50m spacing) for the Gran Dominicus Reef Ball™ breakwater, and Figure 2 shows the cross-sectional graph of the profile line data for the E Profile line.

**Figure 1. Six Profile Lines Surveyed for the Gran Dominicus Reef Ball™ Submerged Breakwater in the Dominican Republic. Additional profile lines are surveyed further east (to the left) and west (to the right) to determine effects on adjacent beaches.**

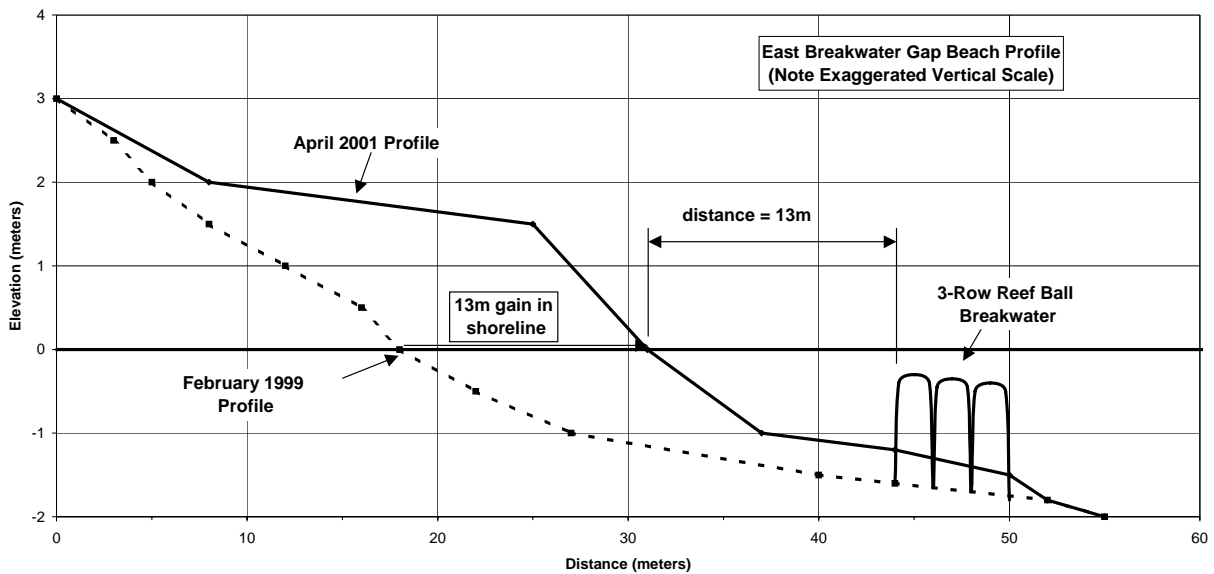
**Figure 2. Cross-section of Beach Profile Showing Changes - seaward advance of the shoreline of 13m and gain in sand volume of 44 cubic meters per meter of shoreline.**

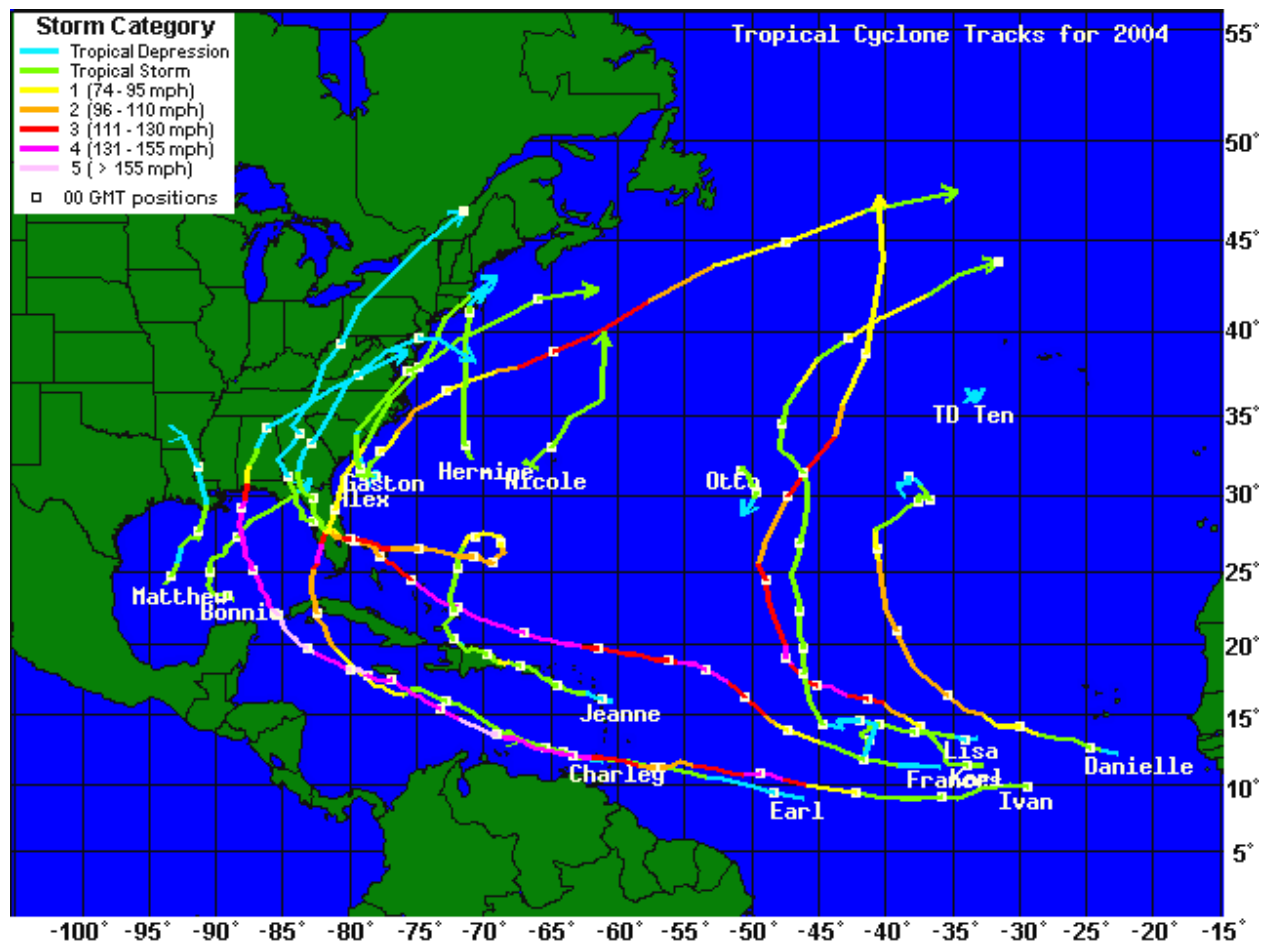
Figures 3 and 4 show the hurricane tracks for 2005 and 2005. Hurricane Ivan in September 2004 produced large waves and water levels that resulted in the breakage and movement of some of the Reef Ball units. However, as presented in this section of the report, the problems were due to improper fabrication of the units, improper anchoring of the units (caused by the improper fabrication), and improper location of units (based on water depths and unit sizes).

Figure 3. 2005 Hurricane Tracks – Hurricane Ivan affected Mayan Palace project area.

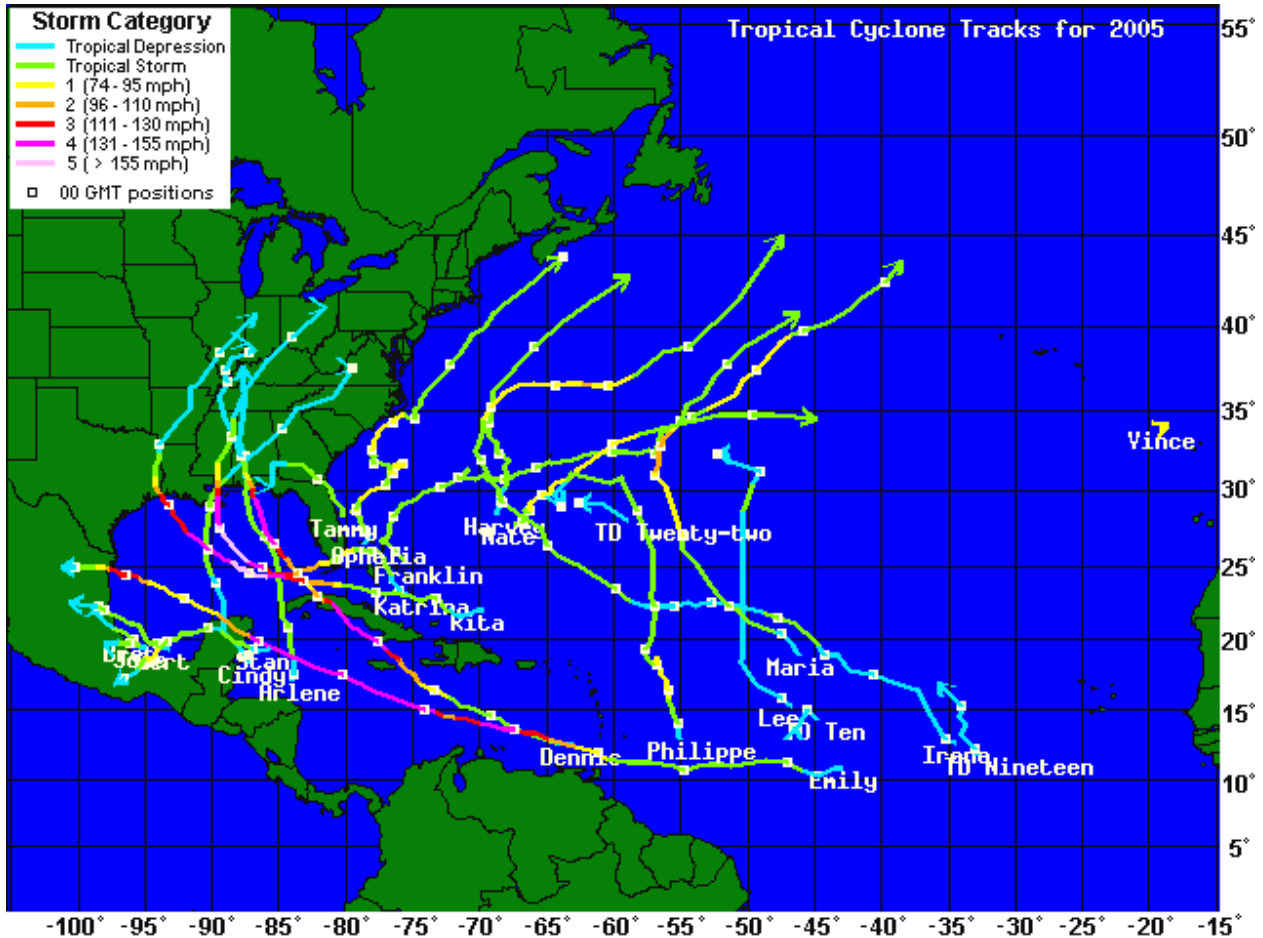
**Figure 4. 2005 Hurricane Tracks – Hurricane Emily affected Mayan Palace project area.**
